# THE TROUBLE WITH VALLEY SLOPES: LANDSLIDES

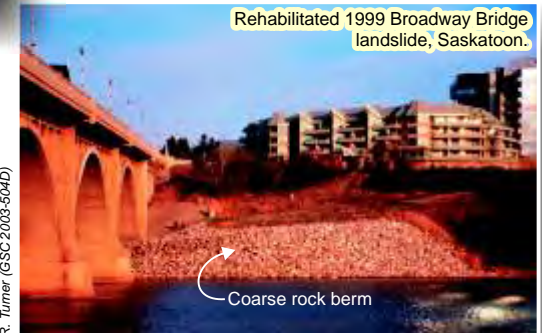
Rehabilitated 1999 Broadway Bridge landslide, Saskatoon.

Coarse rock berm

In 1999, walkers on the Meewasin Trail noticed cracks in the soil beside the Broadway Bridge over the South Saskatchewan River in Saskatoon. Within a week, the land had moved several metres. The cause of the landslide was a plugged and leaking underground water drain that elevated water pressures in the slope materials. To stabilize the landslide, the underground drain was repaired, and a berm of coarse rock was placed along the river edge to hold the slope in place and prevent bank erosion.
